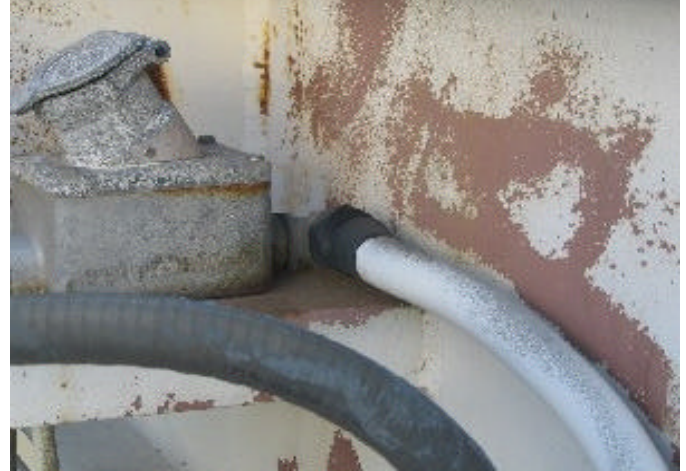
F-108

ARE ELECTRICAL INSTALLATIONS MADE IN ACCORDANCE WITH API RP 500 AND API RP 14F OR API RP 505 AND API RP 14FZ?

THE ELECTRICAL CONNECTION UNDER THE HELIPORT IS NOT PROPERLY TERMINATED.

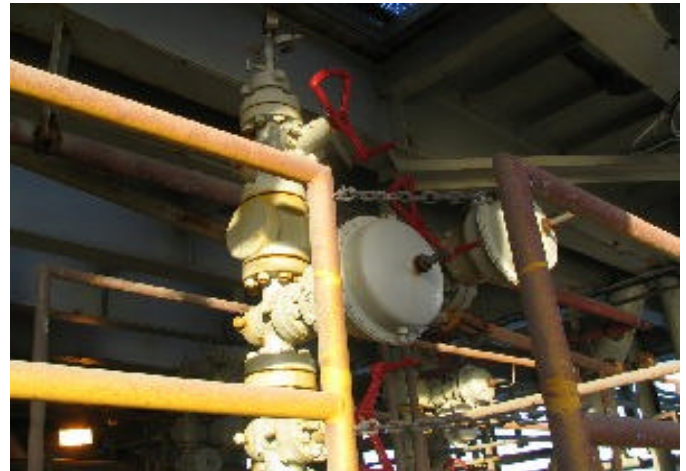
G-101

IS EACH COMPLETION IDENTIFIED AS REQUIRED AT THE WELLHEAD?

WELL A-17 DOES NOT HAVE A WELL IDENTIFICATION SIGN.

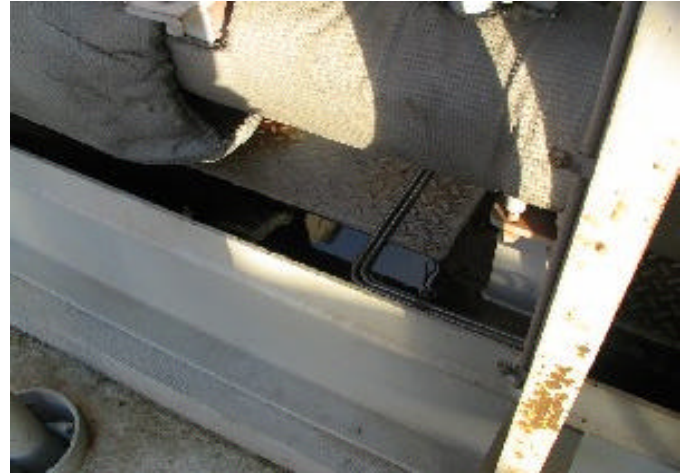
G-112

DOES THE LESSEE PROVIDE FOR THE SAFETY OF ALL PERSONNEL AND TAKE ALL NECESSARY PRECAUTIONS TO CORRECT AND REMOVE ANY HAZARDOUS OIL AND GAS ACCUMULATION OR OTHER HEALTH, SAFETY, OR FIRE HAZARDS?

THE DRIP PAN ON THE M-9 COMPRESSOR HAS STANDING OIL.

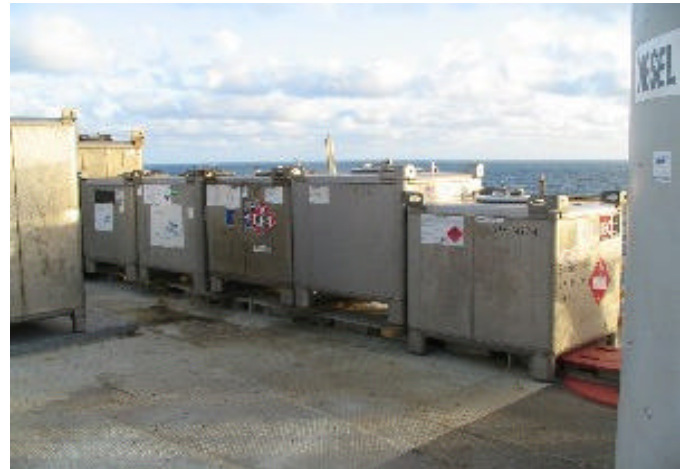
G-251

ARE SKID-MOUNTED EQUIPMENT, PORTABLE CONTAINERS, SPOOLS OR REELS, AND DRUMS CLEARLY MARKED WITH THE OWNER'S NAME WITH A MEDIA DURABLE ENOUGH TO RESIST THE EFFECTS OF THE ENVIRONMENTAL CONDITIONS?

THE WARNING LABELS ON THE CHEMICAL TANKS ARE NEITHER VISIBLE NOR ACCESSIBLE.

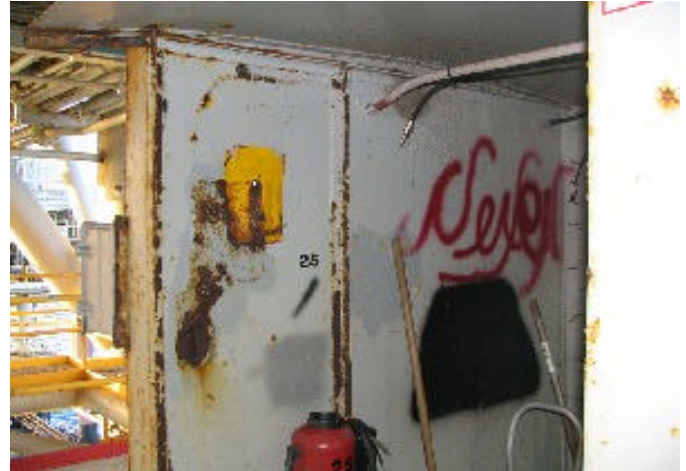
Z-110

PROBABILITY THAT EYE INJURY MAY OCCUR.

THERE IS A MISSING EYE WASH STATION; CHLORINE AND BATTERIES ARE PRESENT.

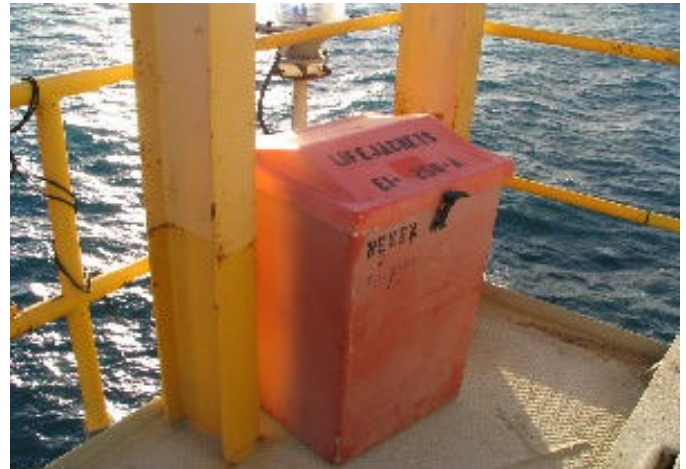
Z-150

IS A WELL-MAINTAINED, APPROVED TYPE I LIFE PRESERVER PROVIDED FOR EACH PERSON AND STORED IN AN EASILY ACCESSIBLE LOCATION ON A MANNED OCS PLATFORM?

IN THE LIFE JACKET CONTAINER LOCATED NEAR THE DIESEL TANK, TWO OF THE LIFE JACKET'S HAVE LIGHTS WITHOUT VISIBLE EXPIRATION DATES.
